**MARYLAND HISTORICAL TRUST  
NR-ELIGIBILITY REVIEW FORM**

Property Name: Bridge No. 1016 Inventory Number: AL-VI-C-338

Address: MD 935 over Georges Creek City: Pekin Zip Code:

MARYLAND INVENTORY OF HISTORIC BRIDGES  
HISTORIC BRIDGE INVENTORY  
MARYLAND STATE HIGHWAY ADMINISTRATION/  
MARYLAND HISTORICAL TRUST

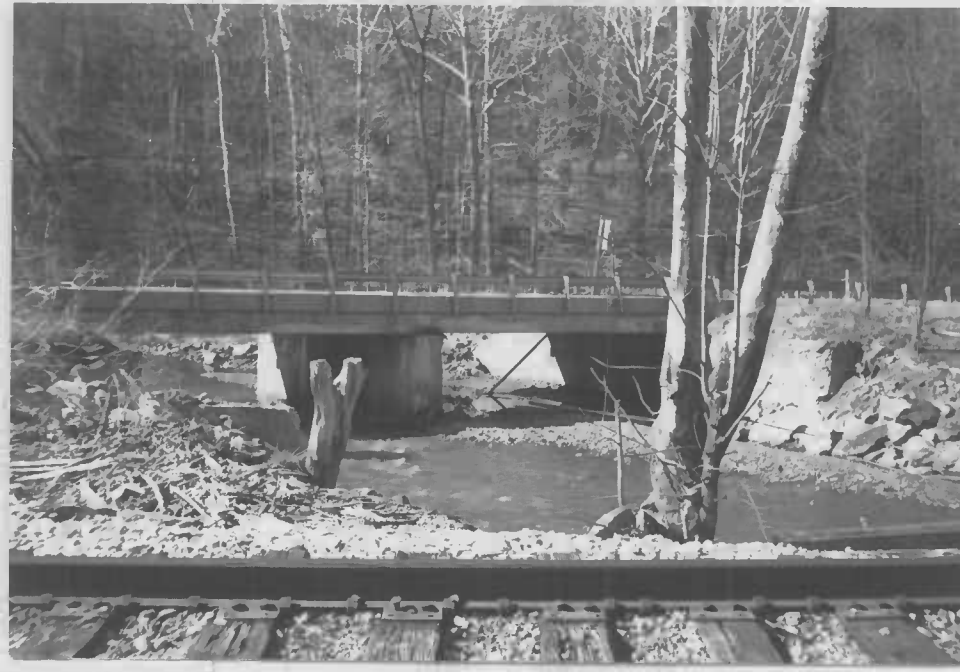
1. AL-VI-C-338
2. MC 935 over George's Creek
3. Allegany Co, MD
4. Ryan McKay
5. 3/97
6. MD SHPO
7. Upstream elevation
8. 1 of 6

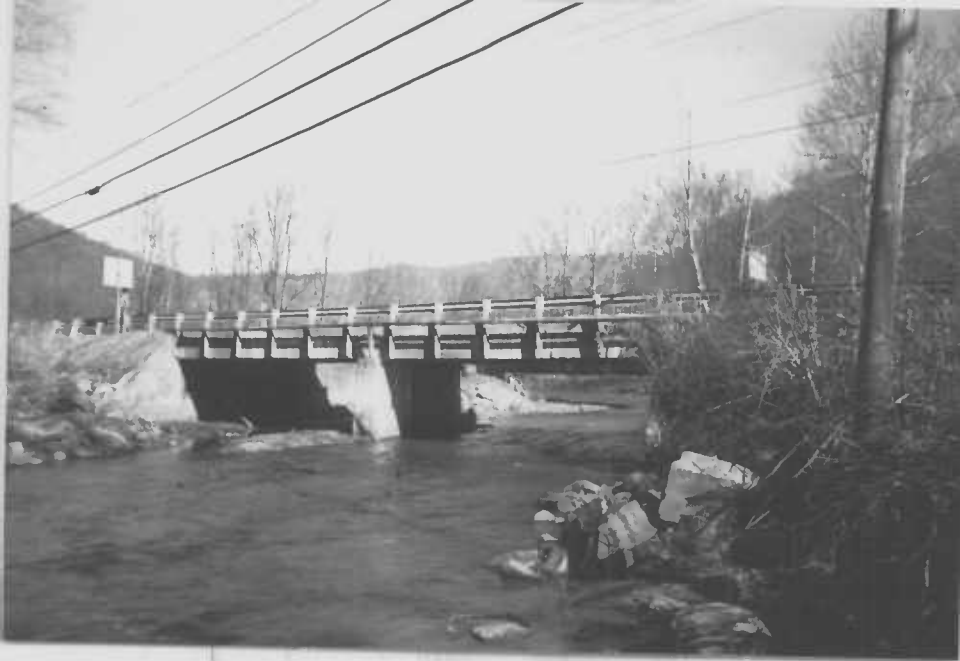
- 1 AL-VI-C-338
- 2 MD 935 over George's Creek
- 3 Allegany Co, MD
- 4 Ryan McKay
- 5 3/97
- 6 MD SHPO
- 7 Downstream elevation
- 8 2 of 6

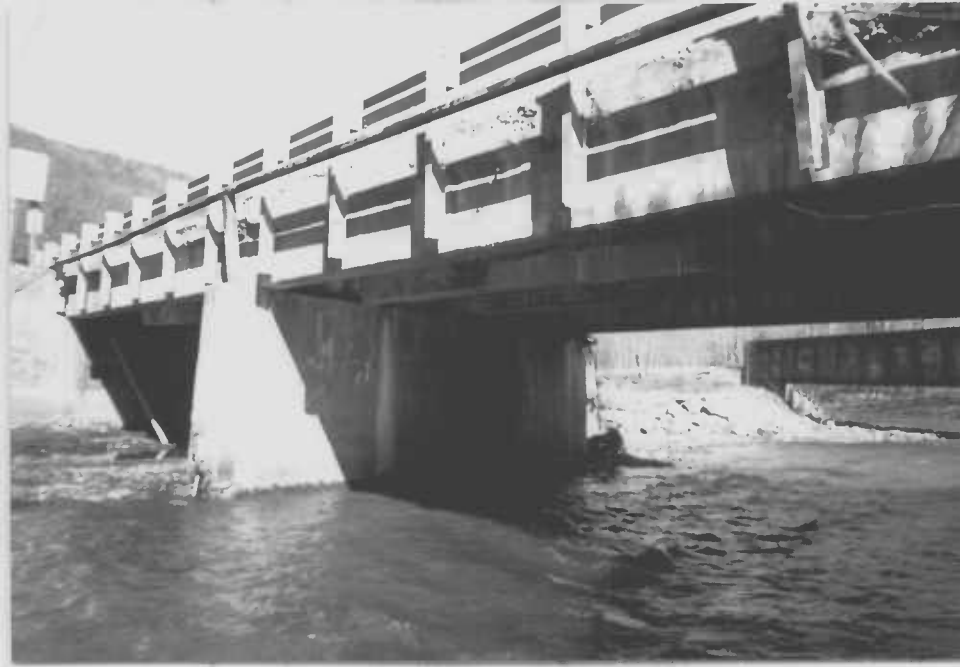
According to the 1996 inspection report, this structure was in fair condition with deteriorated concrete along the pier and superstructure. The asphalt wearing surface has depressions in the traffic lanes. The concrete is spalling on the superstructure, especially on the downstream side. Both the substructure and superstructure have cracks and areas of efflorescence. Also, there is traffic damage at the southwest steel guard rail.

- 1 AL-VI-C-338
- 2 MD 935 over George's Creek
- 3 Allegany Co, MD
- 4 Ryan McKay
- 5 3/97
- 6 MD SHPD
- 7 Detail of pier & beams
- 8 3 of 6

The original concrete parapets were removed, however, the date of removal is unknown. The inspection report from 1996 details numerous repairs to the piers, abutments, beams, and deck with gunite.

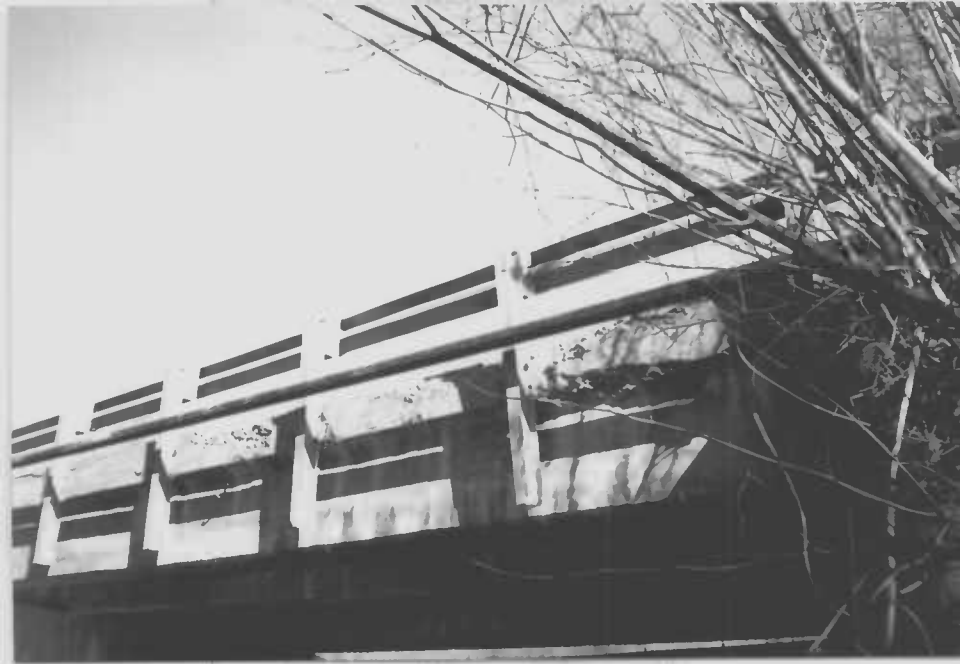
1. AL-VI-C-338
2. MD 935 over George's Creek
3. Allegany Co, Md
4. Ryan McKay
5. 3/97
6. MD SHPO
7. Detail of downstream  
superstructure
8. 4 of 6

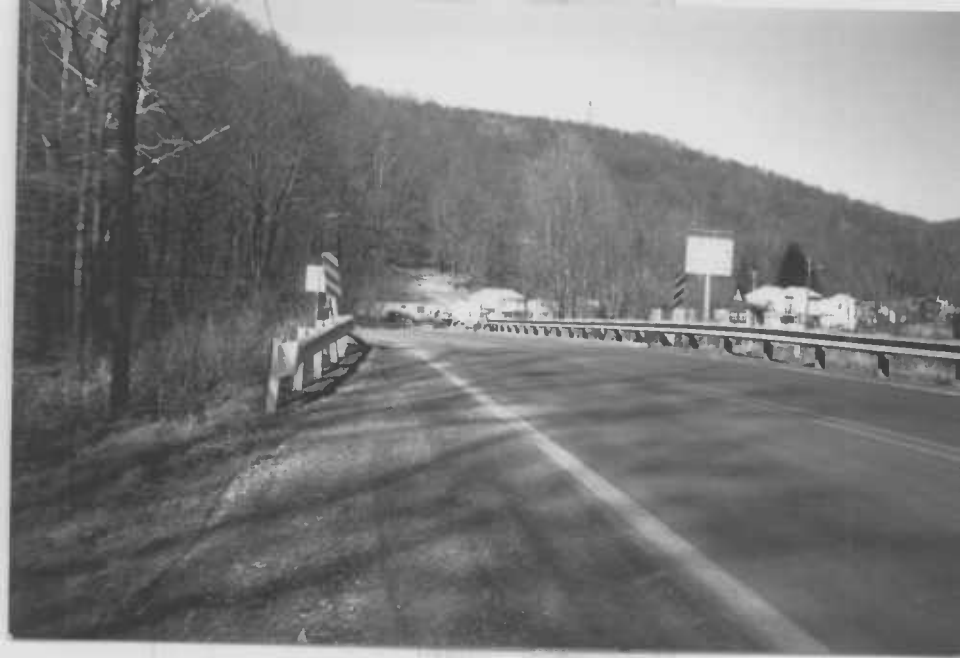
1. AL-VI-C-338
2. MD 935 over Georges Creek
3. Allegany Co, MD
4. Ryan McKay
5. 3/97
6. MD SHPO
7. West approach
8. 5 of 6

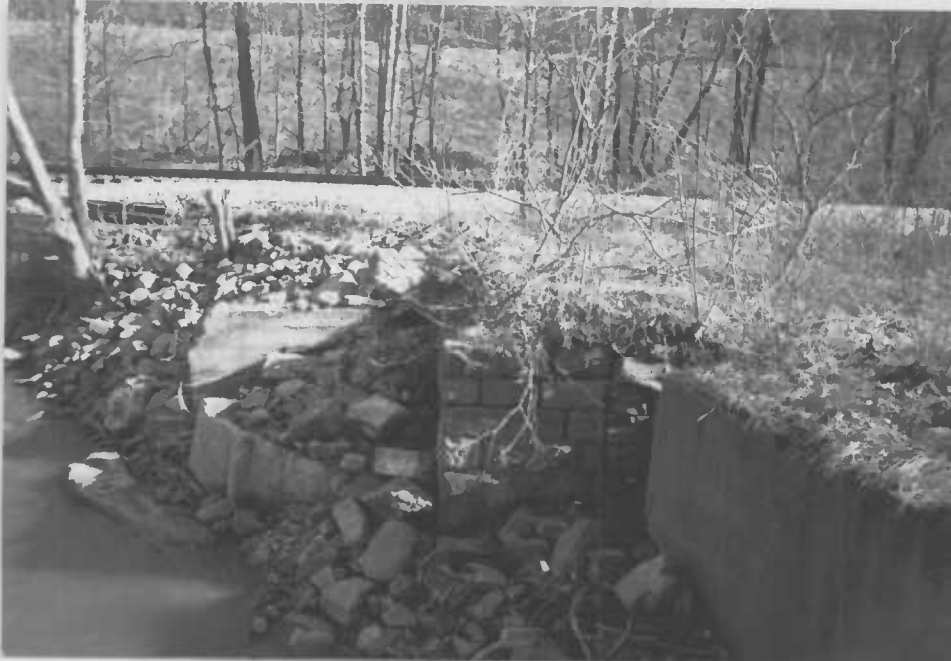
In addition to Bridge 1016, the ruins of an earlier bridge crossing consisting of a partial abutment of coursed cut stone is located just west of the MD 935. It is not known if this earlier bridge was originally constructed for rail or vehicular traffic. Based on the alignment of old route 935, however, it was probably used for vehicular traffic and removed when the road was realigned and new bridge was constructed in 1928. The remaining abutment has significantly deteriorated and lacks sufficient integrity to be considered eligible for the National Register.

- 1 AL-VI-C-338
- 2 MD 935 over George's Creek
- 3 Allegany Co, MD
- 4 Ryan McKay
- 5 03/97
- 6 MD SHPO
- 7 Original Abutment
- 8 6 of 6
